## TECHNICAL INFORMATION REPORT

Teunissen Short Plat  
23121 SE 49<sup>th</sup> CT  
Issaquah WA, 98029

Encompass Engineering Job No. 20636

## **JAZZ RUN SUBDIVISION**

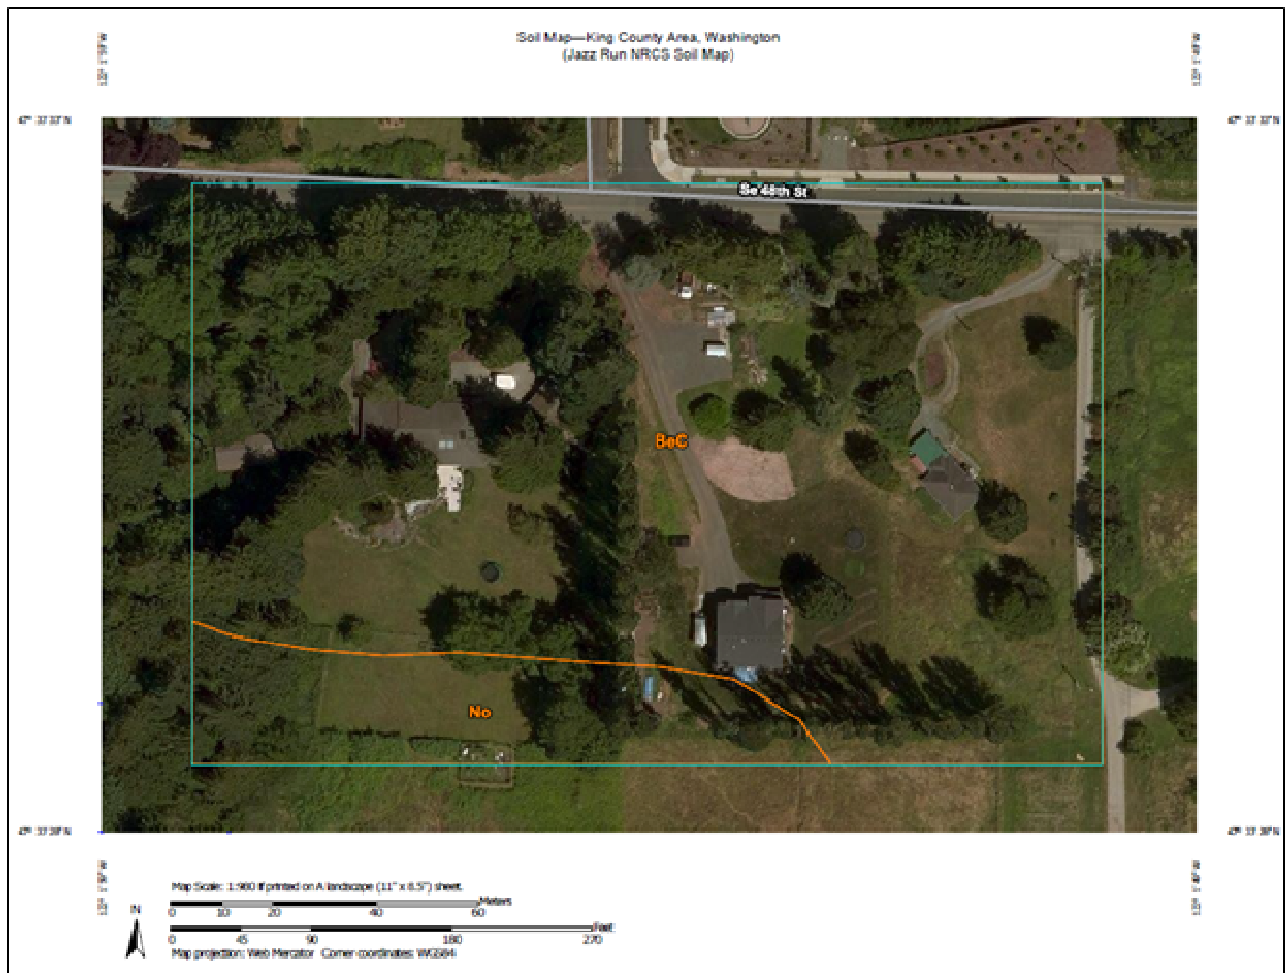
Figure 2.1 – NRCS Soil Map

Stormwater management requirements for this project are based on the 2009 King County Surface Water Design Manual as amended by the City. The City has also adopted Volume IV of the 2005 Department of Ecology Stormwater Management Manual for Western Washington. **Exhibits 4.1** and **4.2**, at the back of Section 4 of this report, show the existing and developed conditions basin maps including sub-basin delineation and discharge points from each basin. The U.S. Department of Agriculture Natural Resource Conservation Service (NRCS) soils mapping for the area is shown in **Figure 2.1 – NRCS Soil Map**, below. Their survey indicates that most of the soils consist of No (Norma sandy loam) and BeC (Beausite gravelly sandy loam).
